TECHNICAL REPORT HL-83-12

# BARKLEY DAM SPILLWAY TAINTER GATE AND EMERGENCY BULKHEADS CUMBERLAND RIVER, KENTUCKY

Hydraulic Model Investigation

August 1983

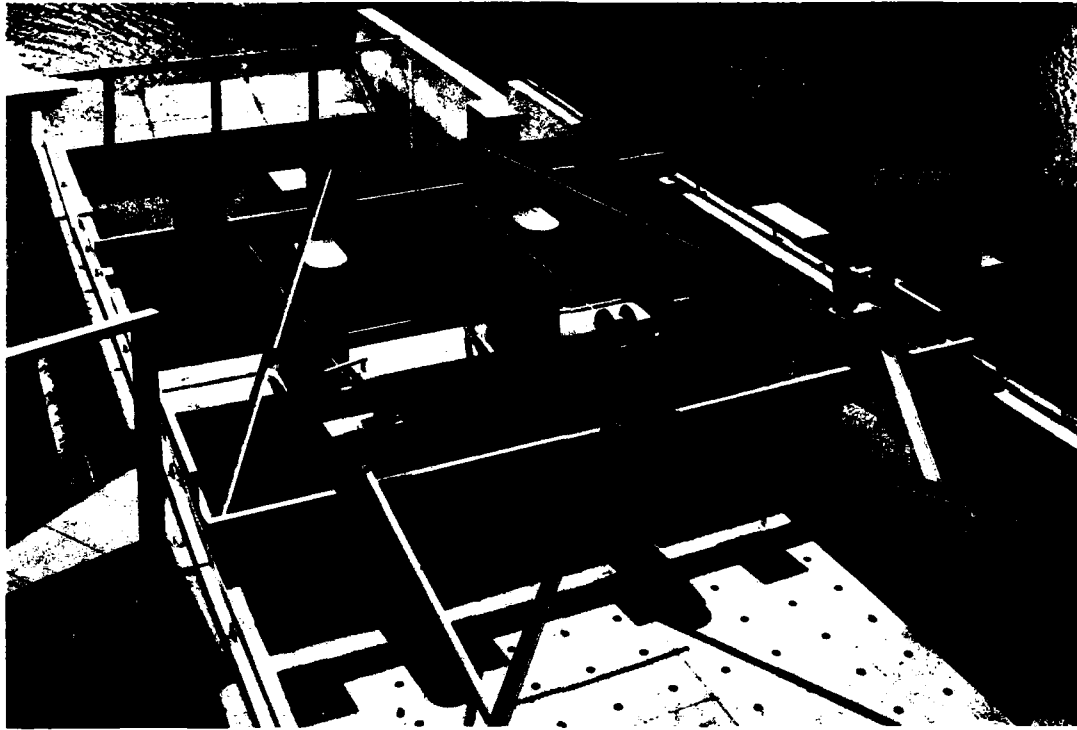
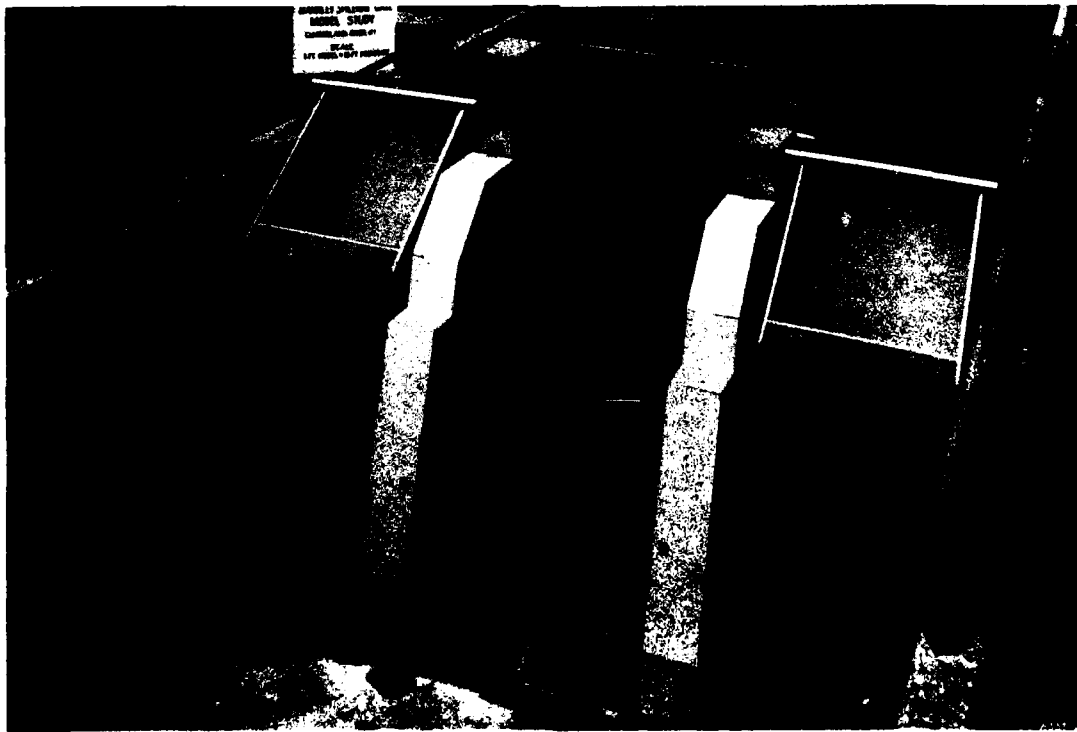
Figure 4. General view of 1:15-scale section model

a. Looking downstream

b. Looking upstream

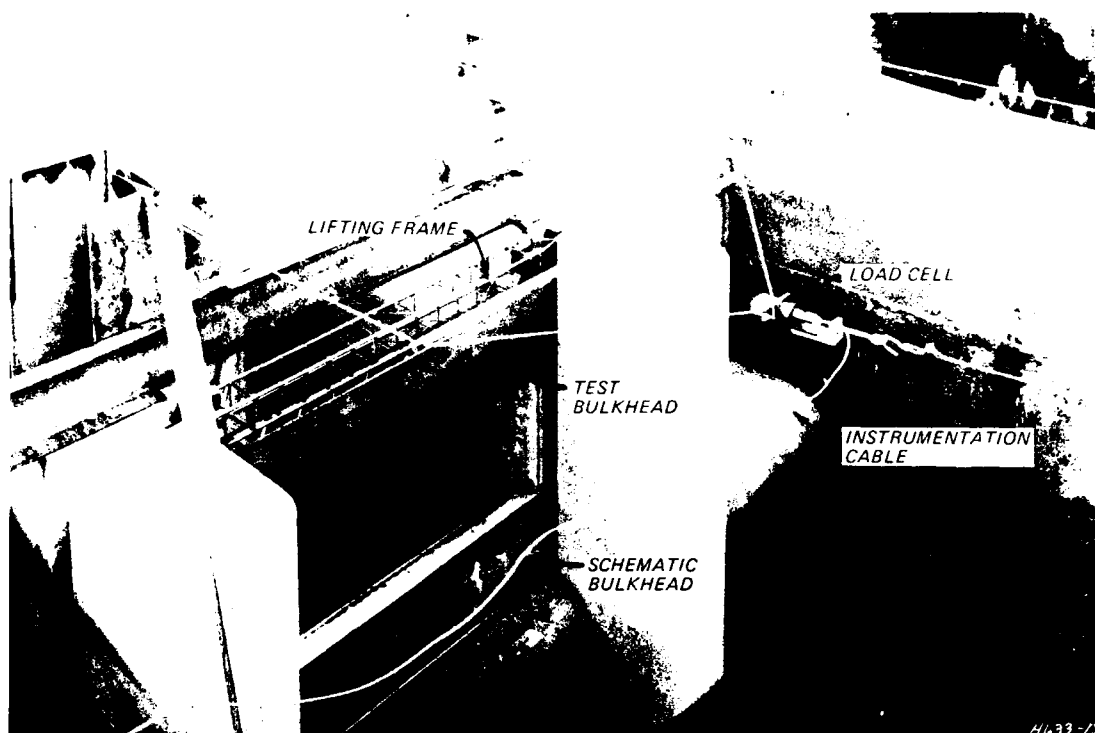
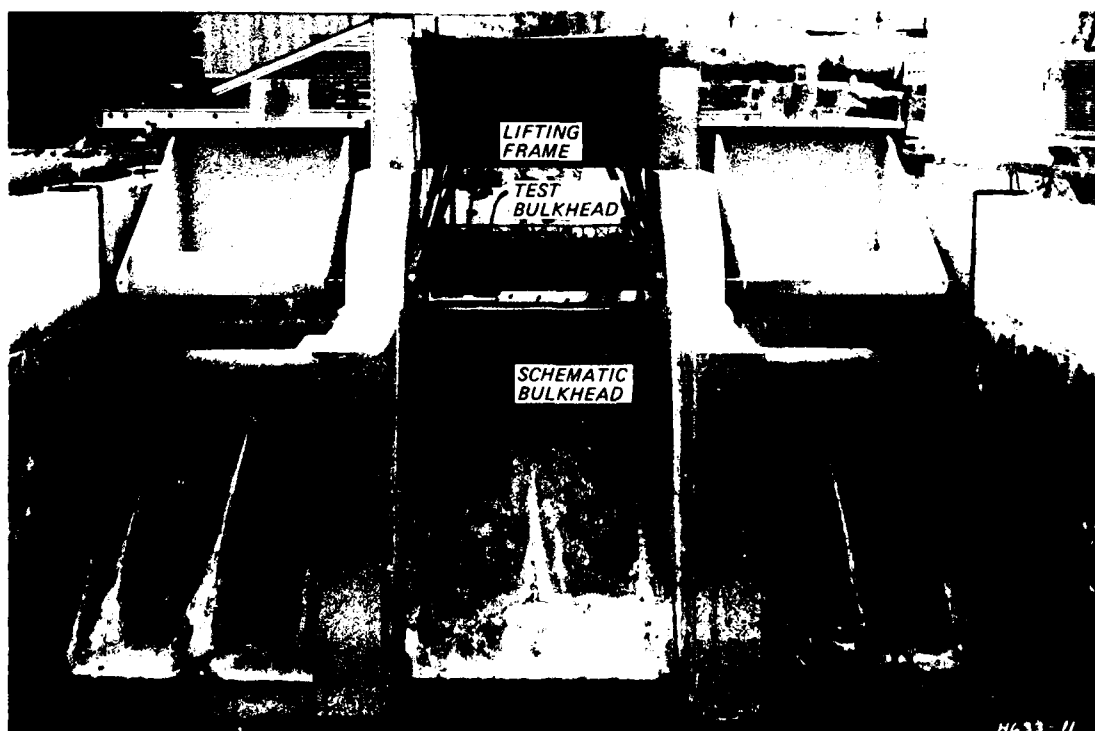
Figure 7. General view of 1:15-scale section model of lifting frame and emergency bulkhead

a. Looking downstream

b. Looking upstream

10. The 1:15-scale model of the emergency bulkheads (Figure 6) was installed in the model used to study bouncing of the tainter gate (Figure 7). The model was constructed of sheet brass and brass pipe to accurately reproduce the bulkhead lifting frame and one bulkhead test gate to scale in size, shape, and weight. Two schematic bulkhead gates were fabricated of sheet

42. Tests were conducted to determine hydraulic forces on the emergency bulkheads under flow conditions with one and two bulkhead sections already seated on the crest. A schematic bulkhead is shown in Figure 7. These tests were also conducted with the original design bulkheads for pool elevations of 359.0, 354.0, and 346.0 with and without tailwater effects. Maximum vertical hydraulic forces measured with the lifting frame and bulkhead unit set at stationary and 1-ft increments above one seated bulkhead unit are shown in Plates 22-24. Maximum hydraulic forces were measured with a pool elevation of 359.0 and the bottom of the test bulkhead between 1 and 10 ft above the top of the bulkhead seated on the crest. These conditions did not cause flow instabilities. The forces measured with pool elevations of 354.0 and 346.0 were not considered excessive and did not cause flow instabilities.

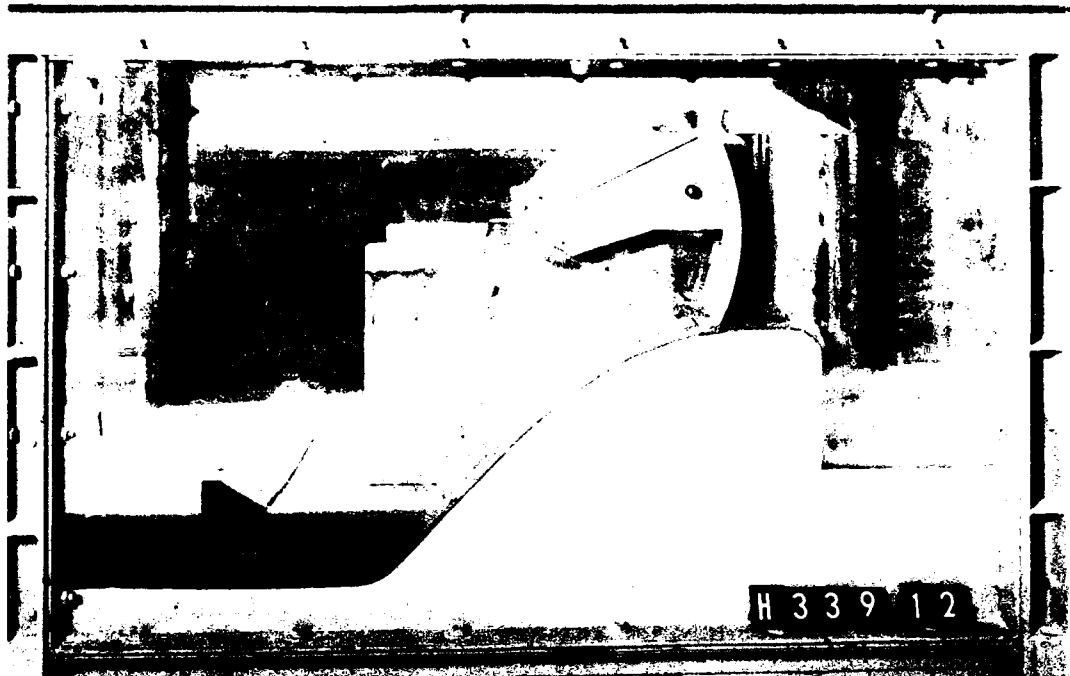
Figure 8. Side view of 1:50-scale section model with type 9 design piers

34. The 21.5-ft pier extension was reduced to 20 ft. Tests to determine the lowest top elevation where satisfactory flow conditions existed were then conducted. The minimum top elevation was found to be el 345.0 as shown in Plate 8 as the type 9 design pier. A dry bed view of the type 9 design pier extension is shown in Figure 8. Flow conditions with the type 9 pier extension are shown in Photo 3. Flow conditions were improved over the original design as seen by comparing Photos 2a and 2b with 3a and 3b. The type 9 design piers were then placed in the larger 1:15-scale model (Figure 9) to determine the hoist loads.

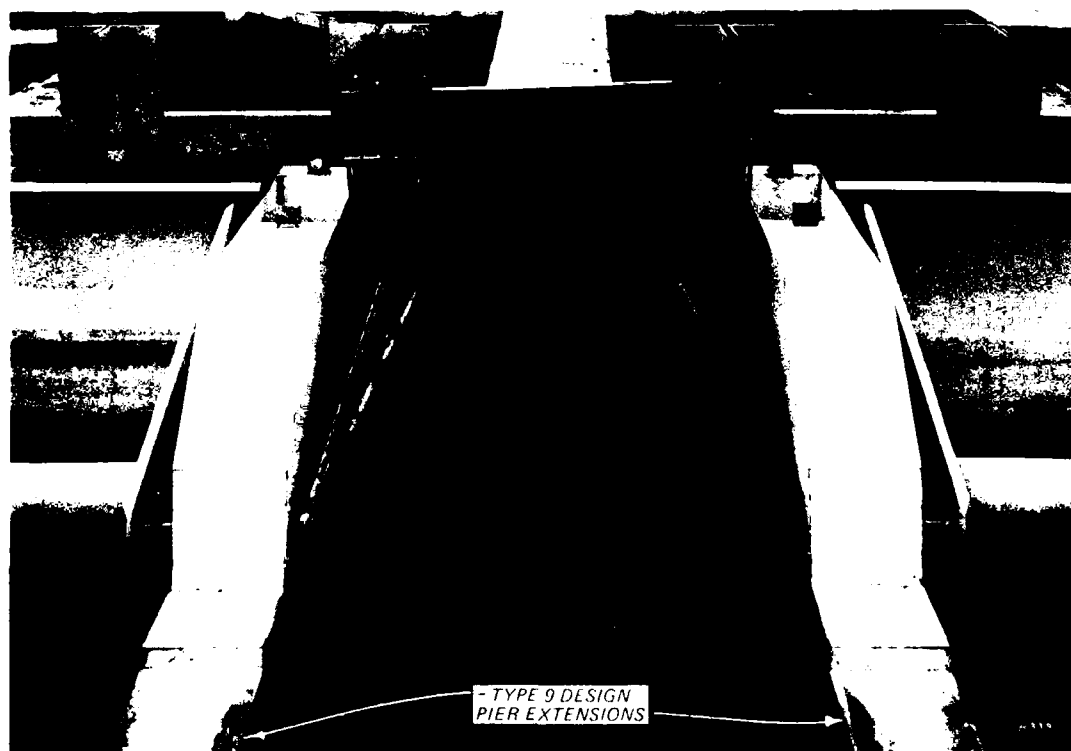
Figure 9. Type 9 design piers in 1:15-scale section model

35. Maximum hoist load fluctuations measured for 12- to 20-ft gate openings with the type 9 design piers are shown in Table 8. The maximum hoist load fluctuation measured with the original design was 142 kips at a 20-ft gate opening and tailwater elevation of 348.5. The maximum value measured with the type 9 design piers was approximately 41 kips and occurred at gate openings of 14 and 16 ft with tailwater elevations of 343.0 and 345.0, respectively, as shown in Table 8. Hoist loads were reduced significantly from those with the original design at the 18- and 20-ft gate openings and were increased slightly with the 12-, 14-, and 16-ft gate openings. Flow conditions present with the type 9 design piers were not severe enough to cause the gate to bounce. Increased hoist loads that occurred with the 12- to 16-ft gate openings were considered insignificant due to their relatively small magnitude. Flow conditions for 12- to 20-ft gate openings with the type 9 design piers and the original design for comparison purposes are shown in Photos 4-8, respectively. The type 9 design piers were found to be the most effective means for preventing bouncing of the tainter gate.

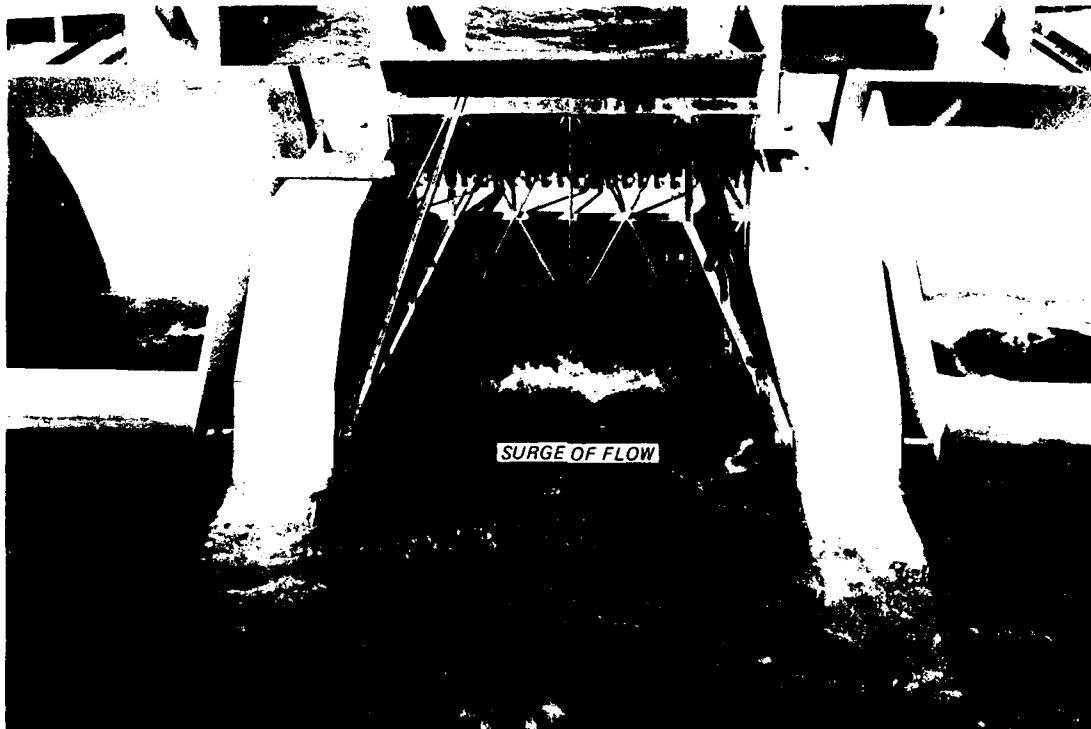
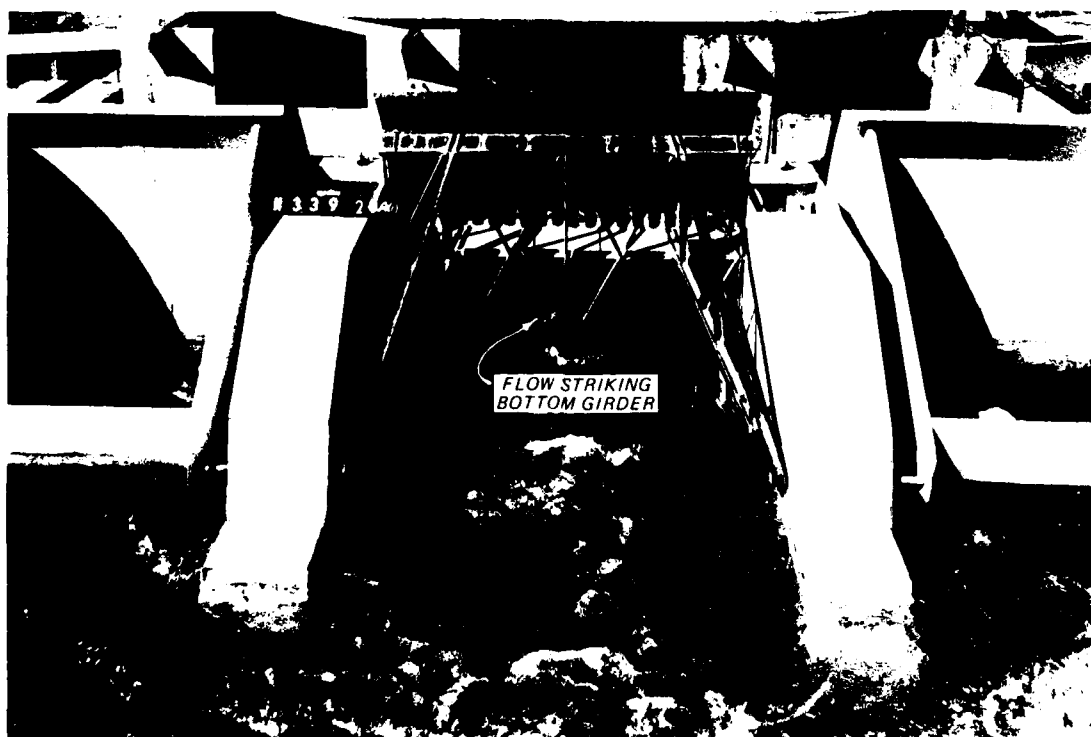
Photo 1. Original design tainter gate; pool el 358.0,  
tailwater el 349.0, gate opening 20 ft

a. Surge of flow underneath tainter gate

b. Flow striking bottom girder of tainter gate

45. The tainter gate bouncing observed under certain flow conditions at the Barkley Dam project is caused by flow oscillation action which has been noted in previous model studies.\* This oscillation action occurs when water-surface differential between pool and tailwater is relatively small and flow is controlled primarily by tailwater. The presence of the tainter gate induces an unstable condition resulting in a periodic oscillation of the water surface in both approach and exit areas. Under the flow conditions experienced at the Barkley project, this oscillation is quite severe and results in a shift of flow control from a submerged controlled flow condition where the gates are partially open and the upper pool is controlled by both the submergence effect of the tailwater and the gate opening, to a free controlled flow condition where the gates are partially open and the particular gate opening controls the upper pool. The submerged controlled flow condition is predominant, but once the free controlled flow condition occurs, the oscillation begins and the associated surges of flow which move back into the gate bay and strike the bottom girder are strong enough to lift the tainter gate causing the bouncing phenomenon. This causes a large fluctuation of the load in the hoisting cables and mechanism.

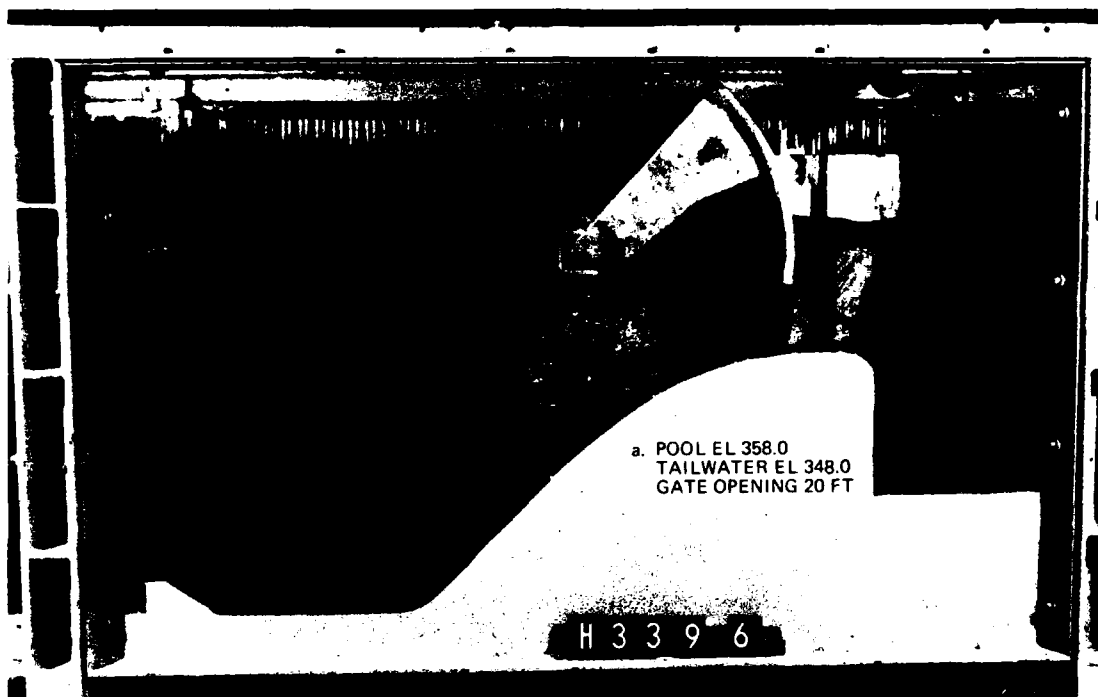
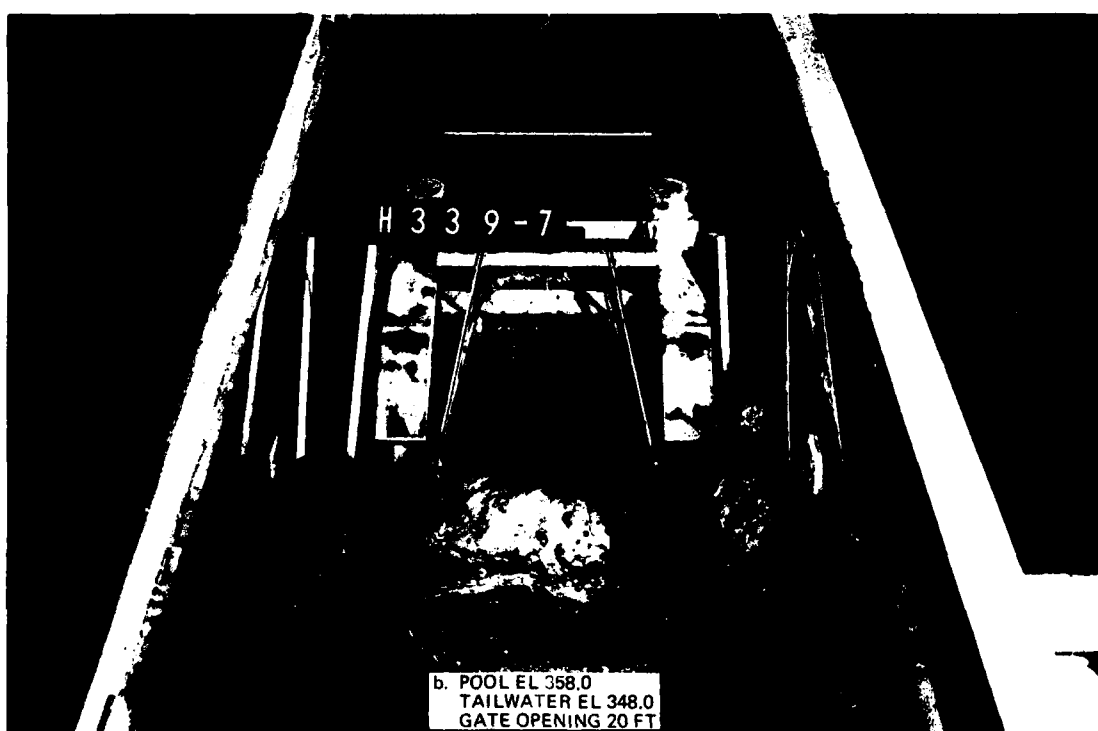
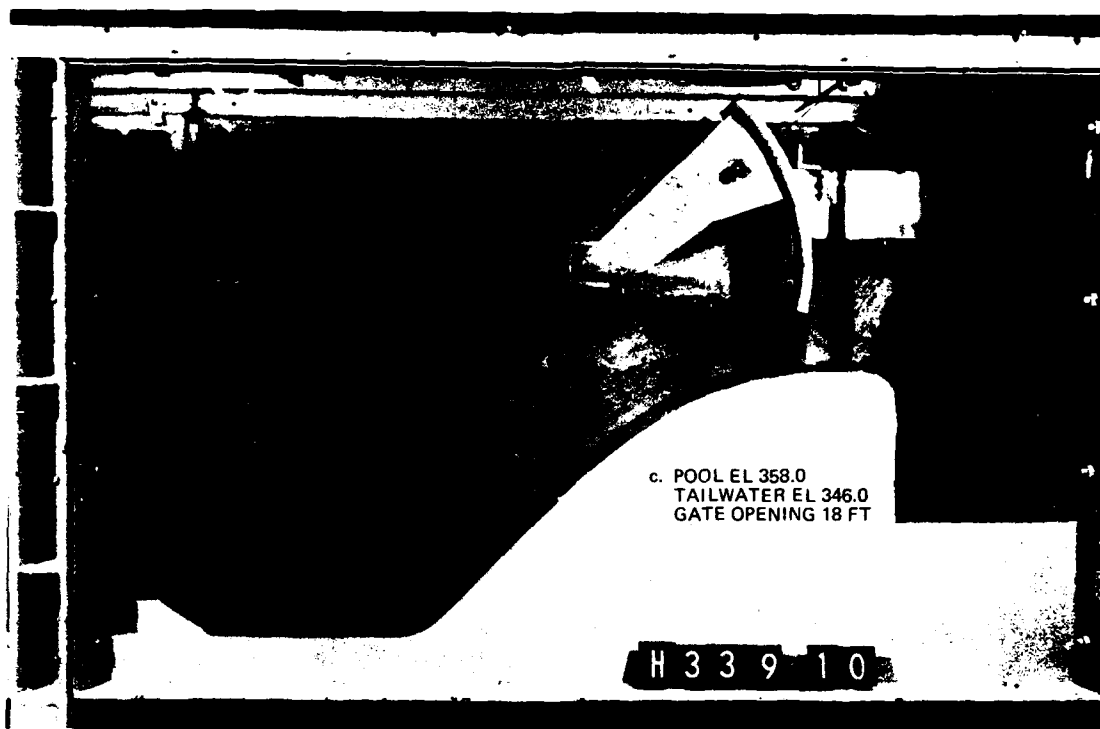
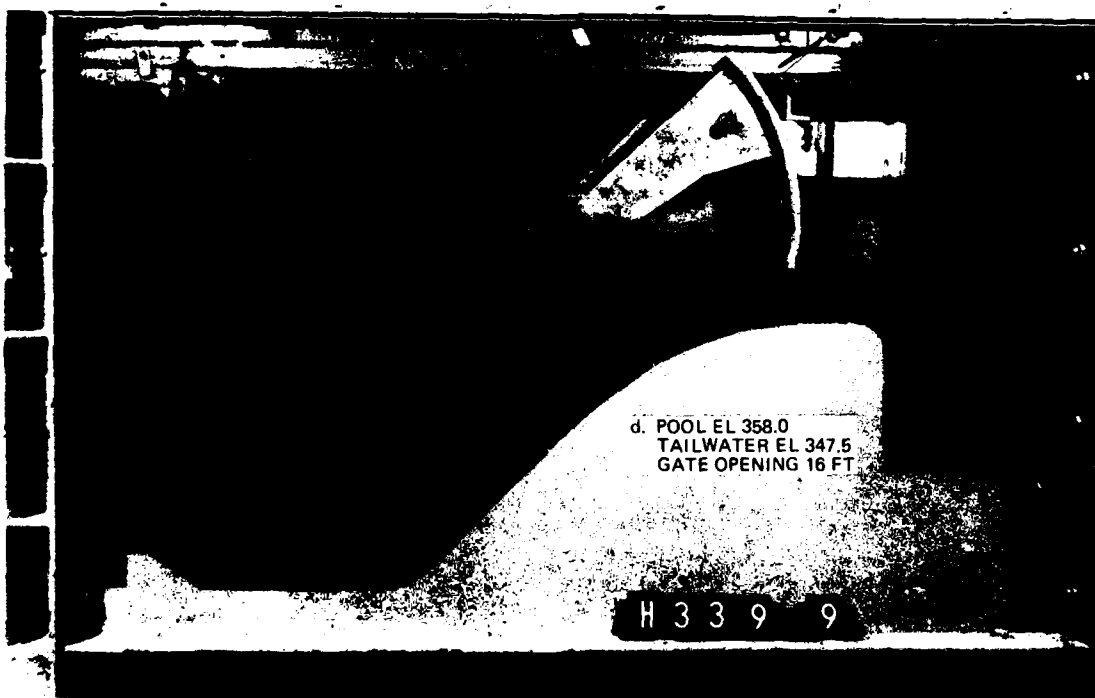
Photo 2. Flow conditions in 1:50-scale section model (Sheet 1 of 2)

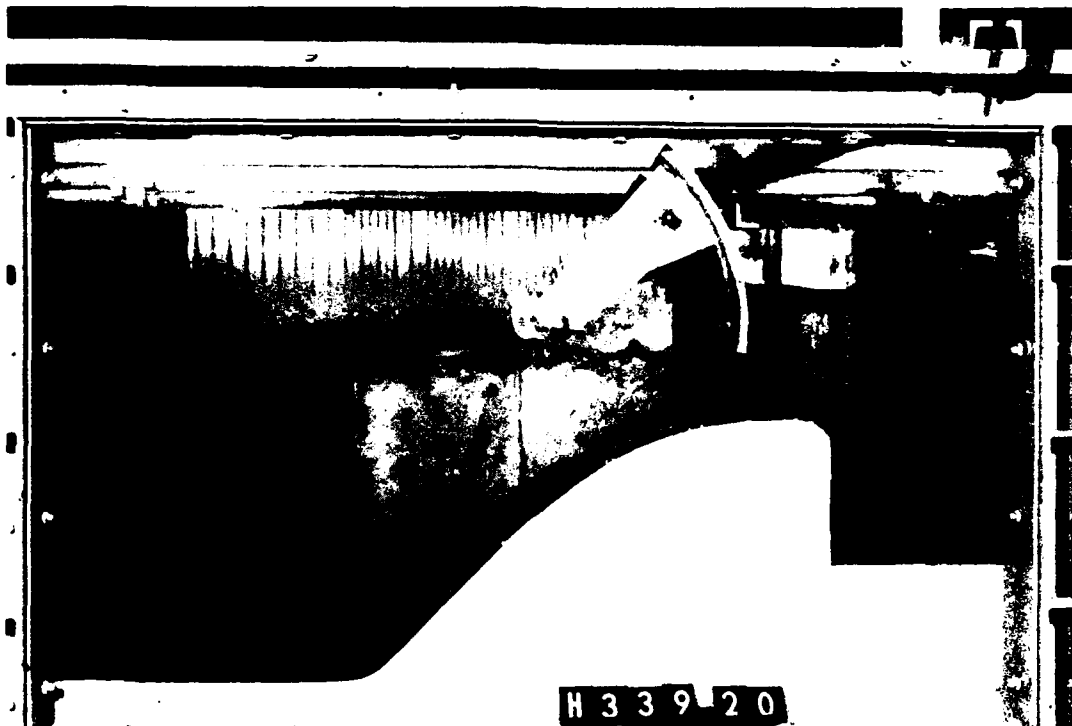
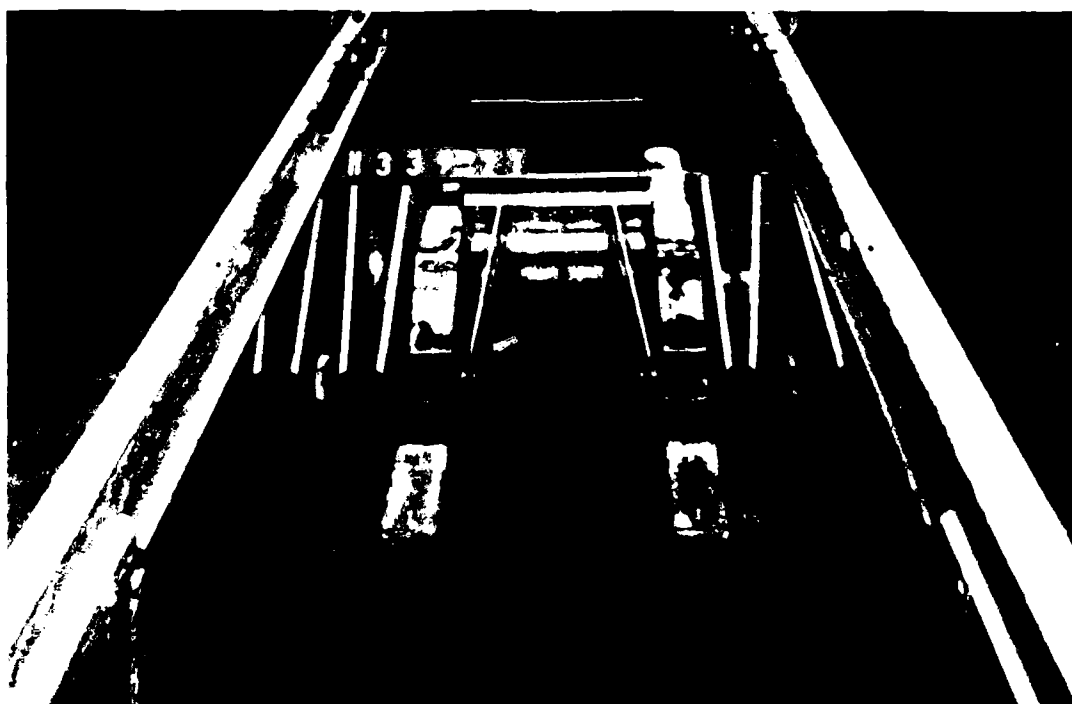
Photo 3. Flow conditions in 1:50-scale section model with  
 type 9 design piers; pool el 358.0, tailwater el 348.0,  
 gate opening 20 ft

49. Extending the gate piers downstream reduced the severity of the flow oscillation to an extent where the gate no longer bounced. The maximum hoist load fluctuation was reduced from 142 kips with the original design to 41 kips by extending the piers 20 ft downstream. The pier extension stabilized flow between adjacent gate bays and reduced the height of the surge of flow at the tainter gate. Some oscillation of flow between bays was still present, but the magnitude was not strong enough to cause the gate to bounce.

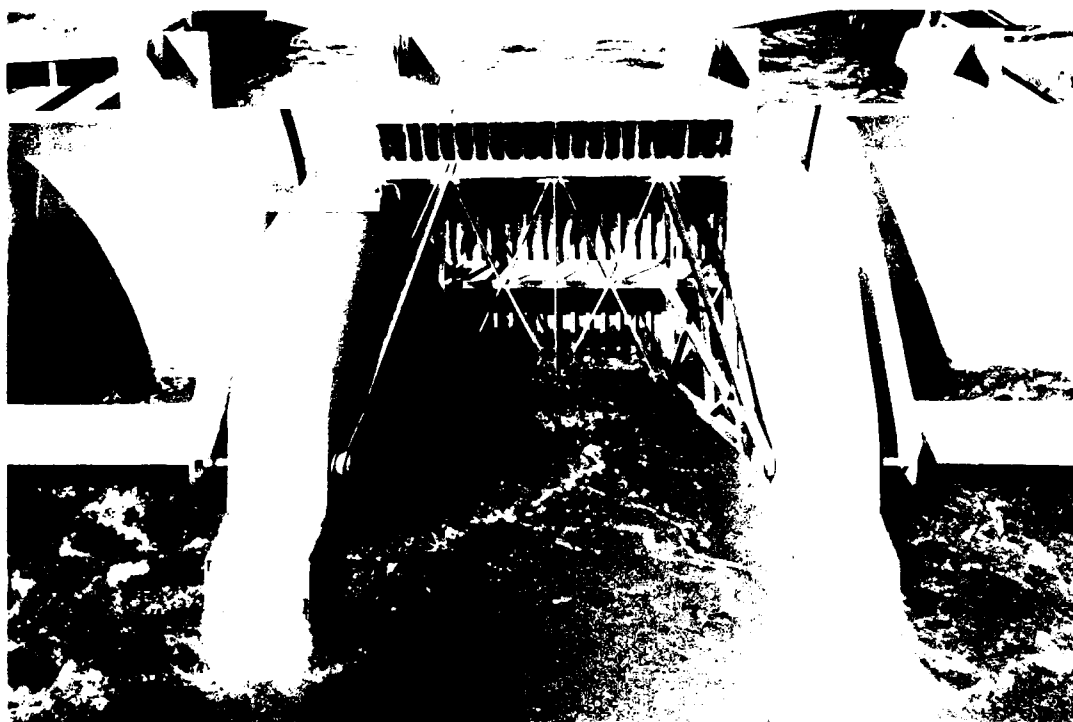
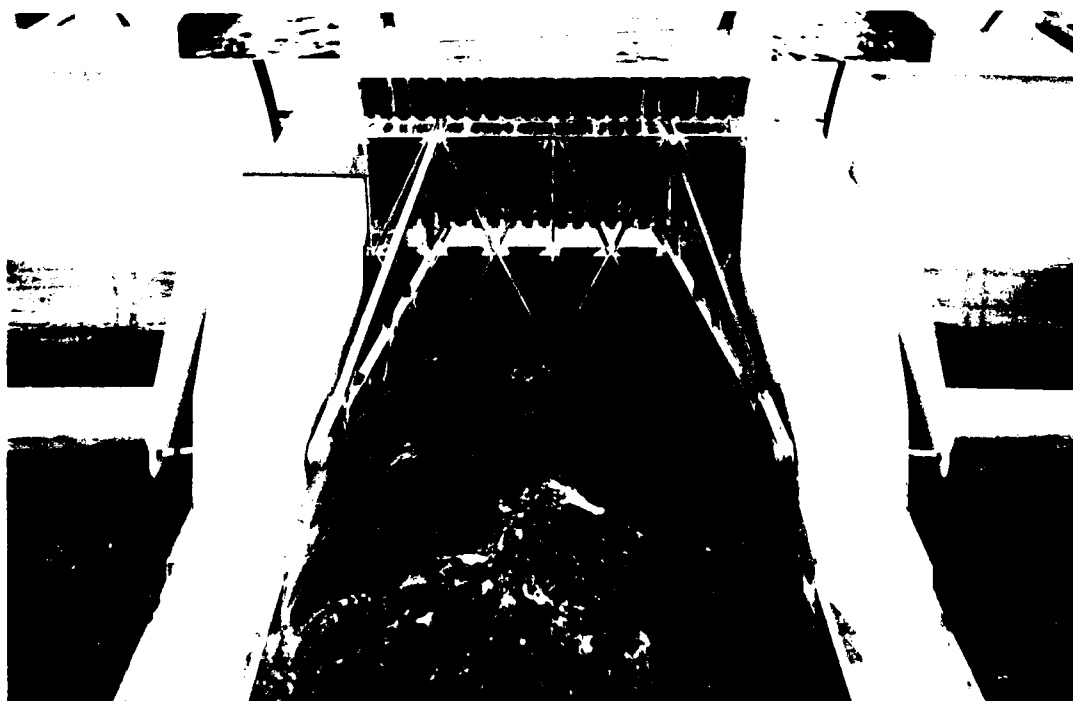
a. Original design

b. Type 9 design piers

Photo 4. Flow conditions; pool el 358.0, tailwater el 343.0,  
gate opening 12 ft

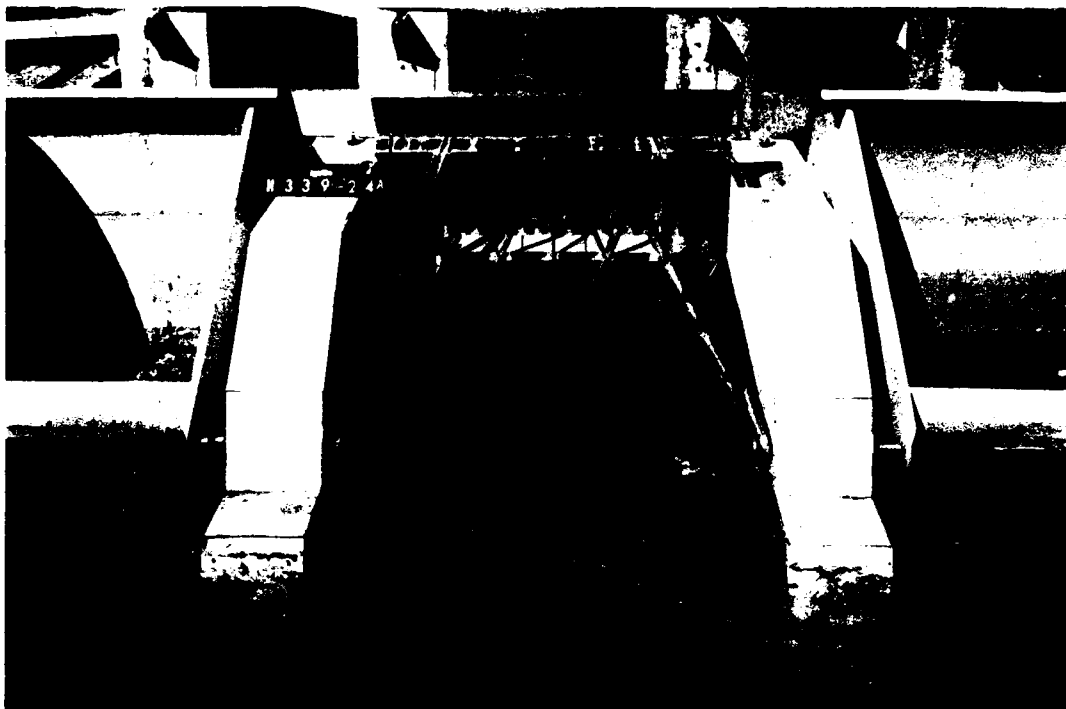
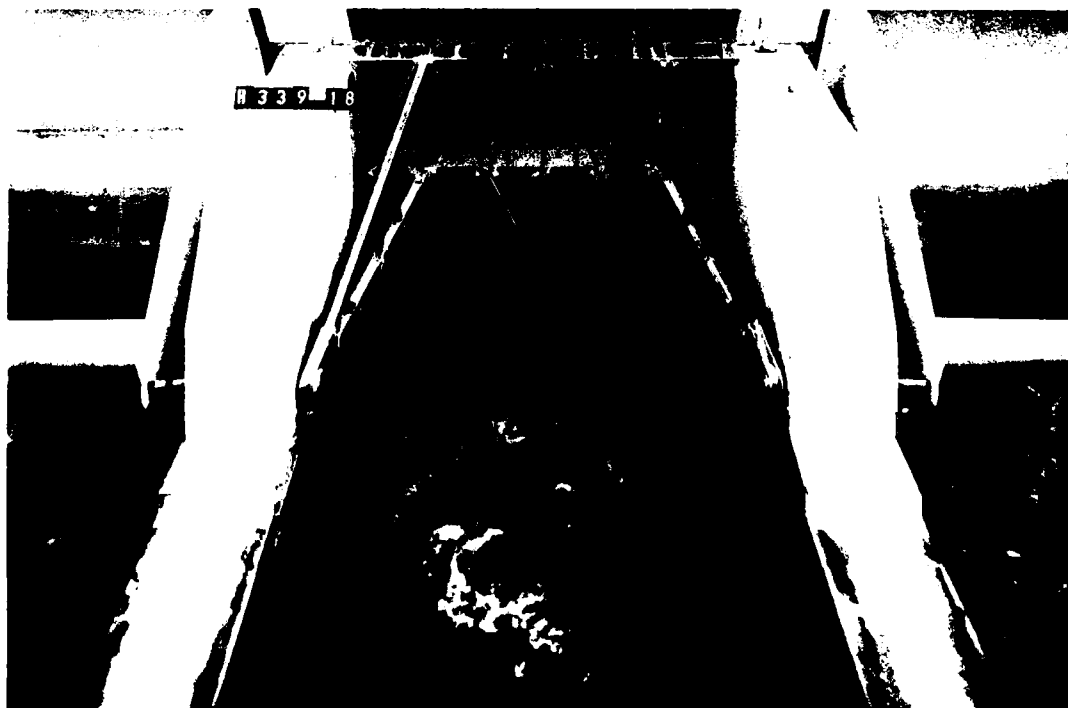
a. Original design

b. Type 9 design piers

Photo 5. Flow conditions; pool el 358.0, tailwater el 344.0,  
gate opening 14 ft

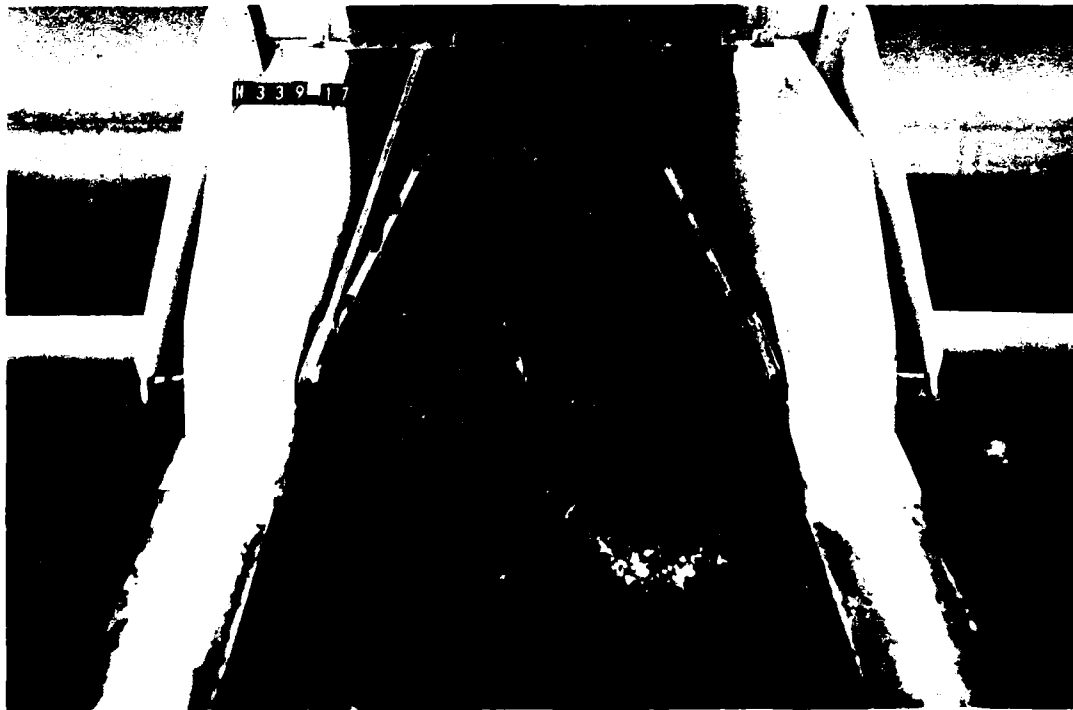
a. Original design

b. Type 9 design piers

Photo 6. Flow conditions; pool el 358.0, tailwater el 346.0,  
gate opening 16 ft

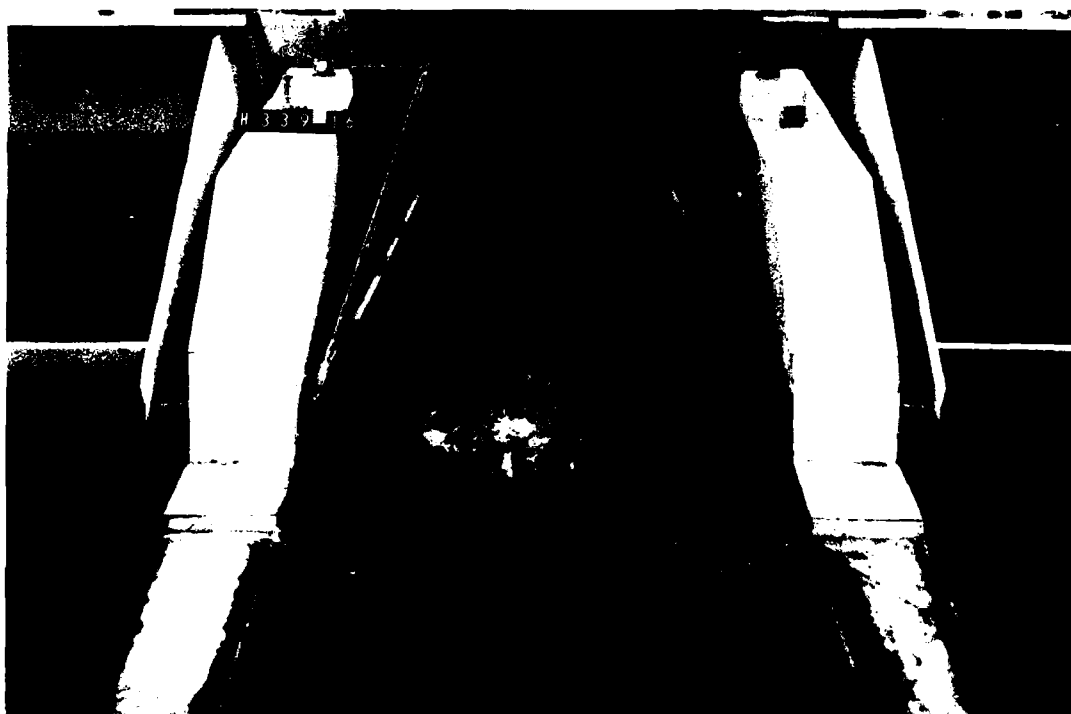
a. Original design

b. Type 9 design piers

Photo 7. Flow conditions; pool el 358.0, tailwater el 346.5,  
gate opening 18 ft

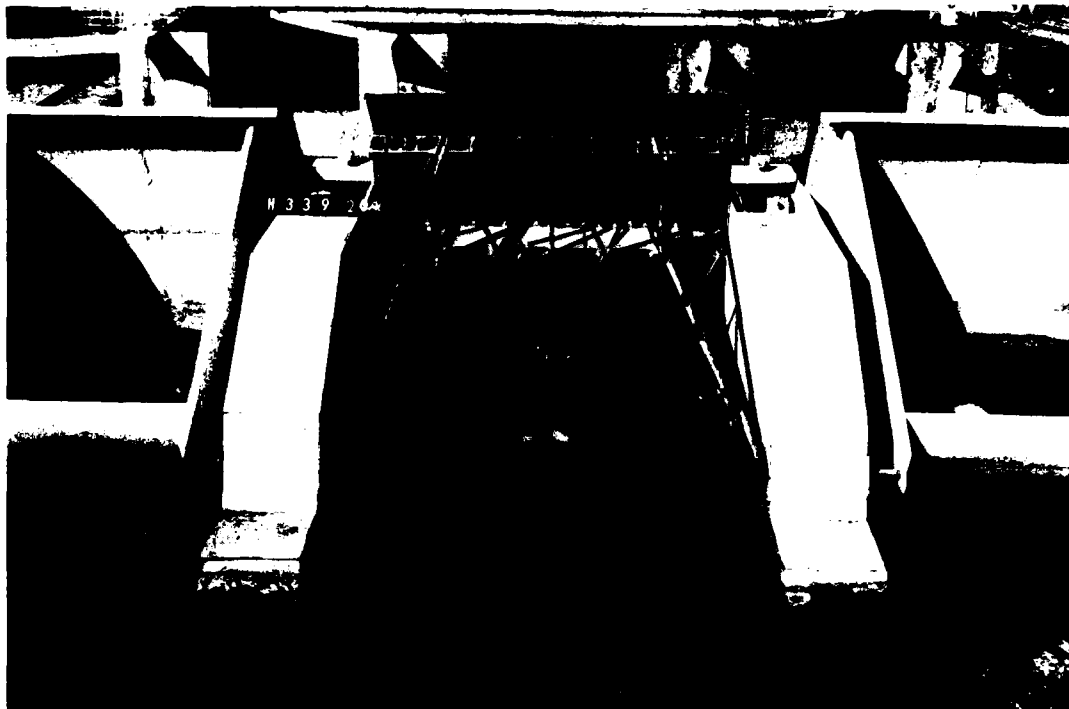
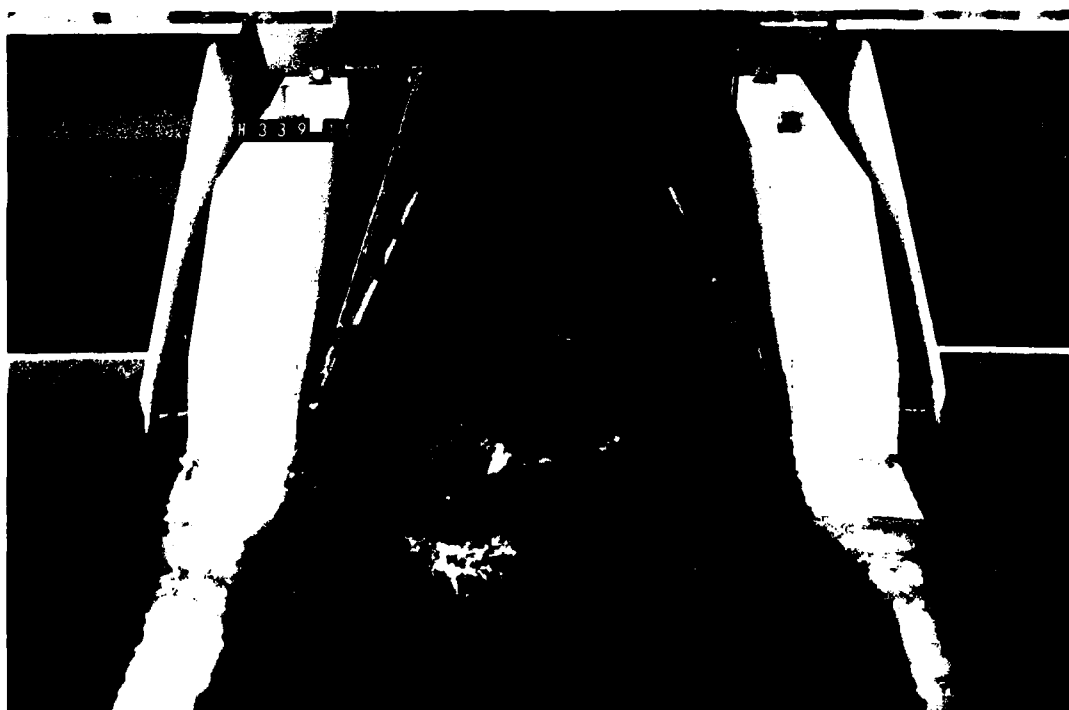
a. Original design

b. Type 9 design piers

Photo 8. Flow conditions; pool el 358.0, tailwater el 349.0,  
gate opening 20 ft

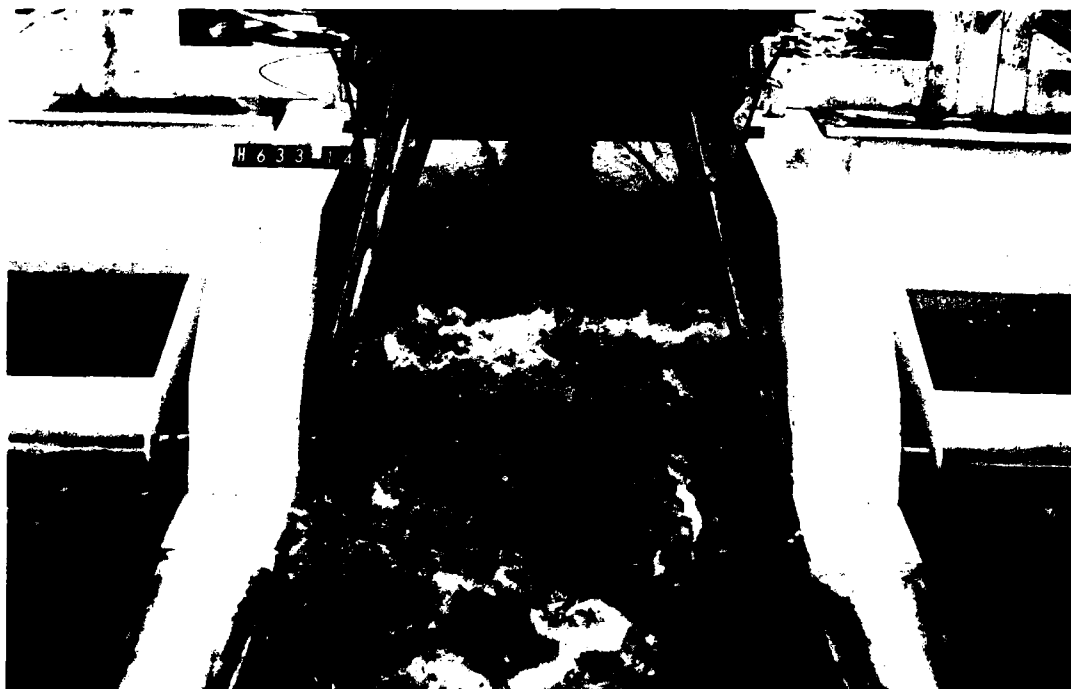
Photo 9. Unstable flow condition; pool el 359.0, tailwater el 348.0,  
bottom of bulkhead 5 ft above crest

The loads were not encountered when the unit was lowered at the prototype hoisting speed. The conditions which caused the large unstable loads, pool el 359.0 and tailwater el 348.0, occur when large discharges must be passed through the structure requiring large tainter gate openings. If tainter gate failure occurred, the remaining gates could be manipulated so as to avoid having to lower the emergency bulkheads until lower tailwater elevations are present. However, if the bulkhead unit and lifting frame are lowered at their rated speeds no problem should be encountered even with those conditions.

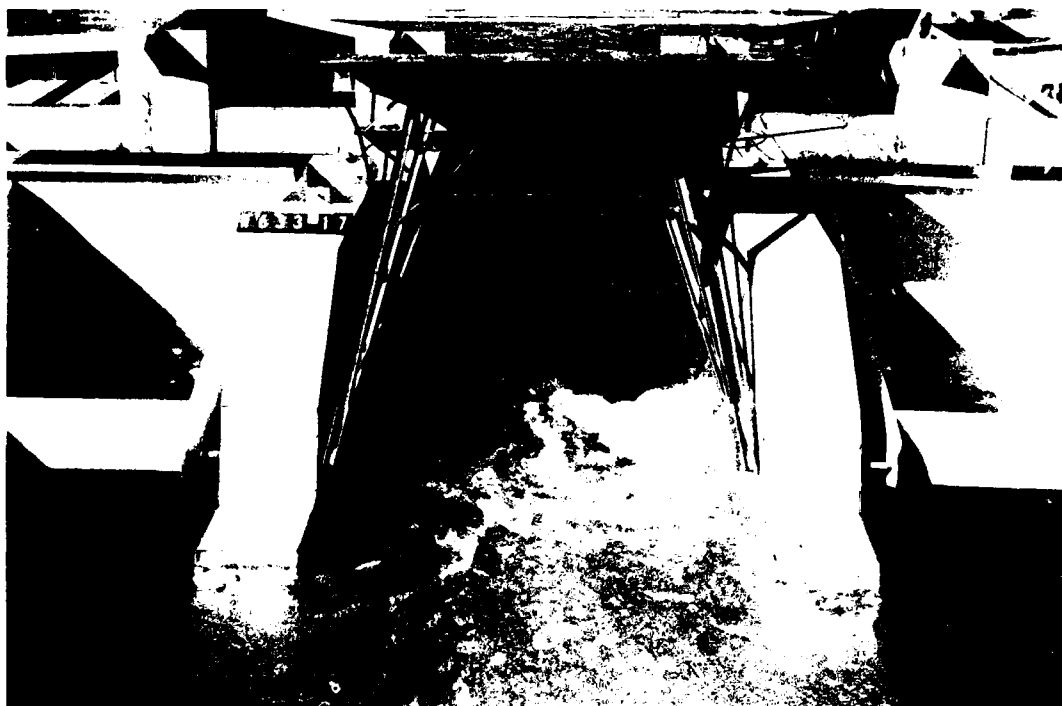
Photo 10. Bulkhead contacts nappe; pool el 354.0, tailwater el 345.0

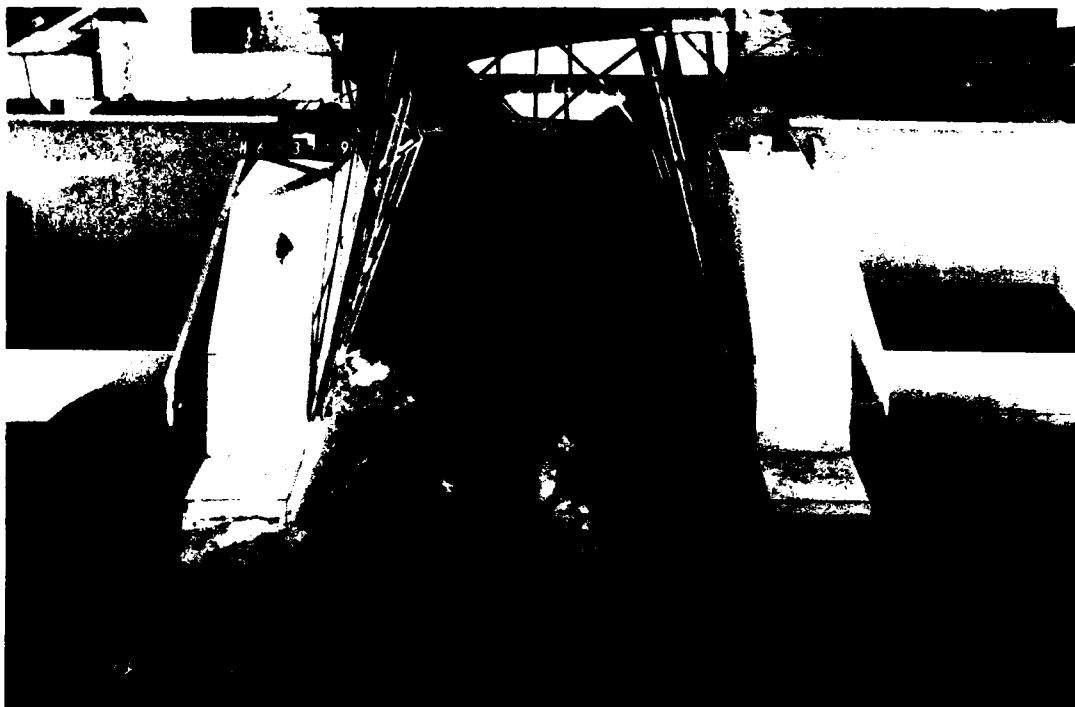
Photo 11. Nappe overtops bulkhead; pool el 354.0, tailwater el 345.0
